# Natural analogue study on the effect of loading pressure on bentonite deformation

Regulatory Standard and Research Department  
Secretariat of Nuclear Regulation Authority (S/NRA/R)

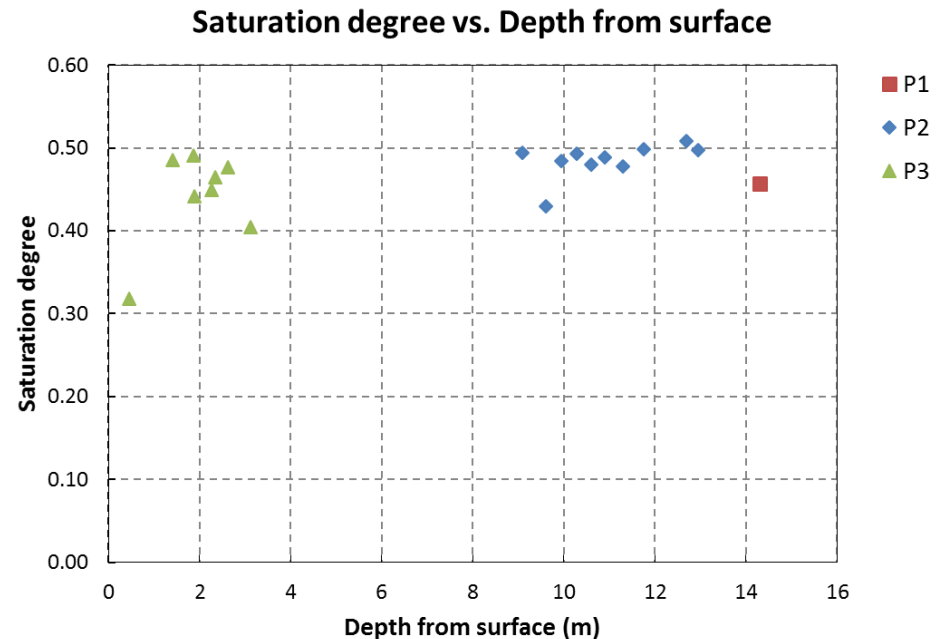
- ✓ Methylene blue adsorption test
- ✓ Most bentonite samples contained 20-30% smectite and some of them contained more than 30% smectite.

- ✓ The degree of saturation of bentonite samples was approximately 50%.
- ✓ There was not a major difference in the degree of saturation among samples except for the near-surface sample.
